EVALUATION OF SCRATCH- AND SPALL-RESISTANT WINDSHIELDS

JOHN R. PLUMER and WILSON C. McDONALD
Army Materials and Mechanics Research Center
Watertown, Massachusetts 02172

AMMRC TR 76-39

December 1976

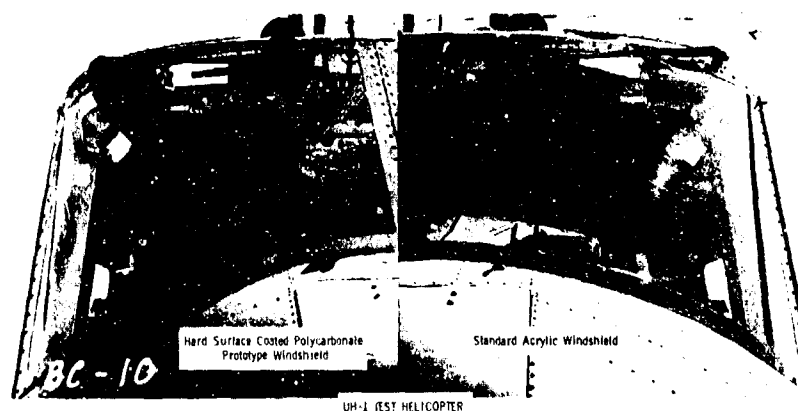
Figure 2. Windshields during flight testing - 385 flight hours.
19-066-141/AMC-74

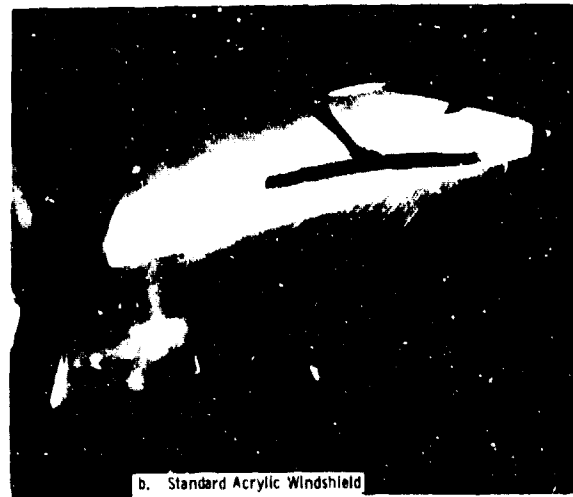
Figure 4. Prototype windshield SN-2 (a) and acrylic windshield (b) at 967 flight hours.

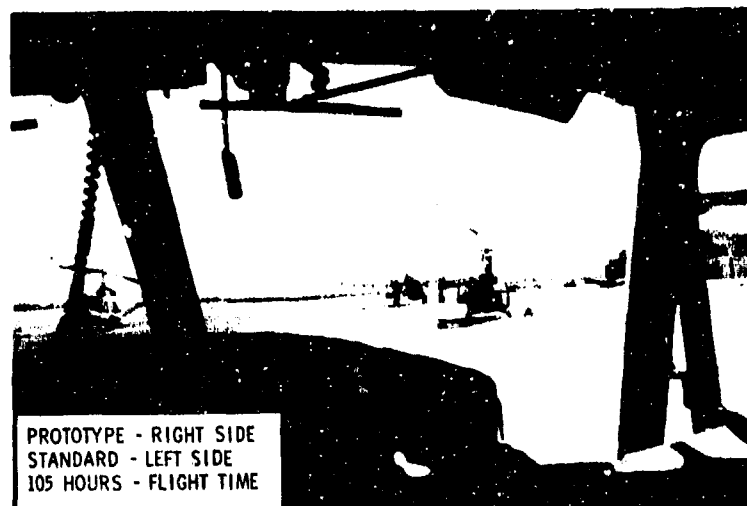
General comments made by the flight test pilots of each of these windshields stated although the distortion was small and in a usually noncritical portion of the windshield (see Figure 5), it caused some eye strain and some orientation difficulties. Other pilots' comments noted the parallax error (due to differences in right-hand and left-hand windshield thicknesses) as a visual annoyance. This could not be resolved within the scope of the program as it would require glass/plastic windshields in both left- and right-hand configurations but would not be a problem in production windshields.

Figure 5. Prototype windshield SN-5, 105 flight hours.
19-066-1728/AMC-75

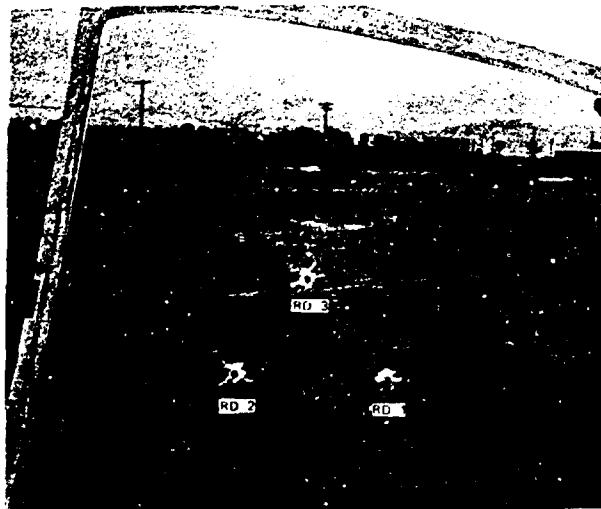
The back-side spalling characteristics of each type of windshield tested are summarized in Table 3. Photographs of the expended test articles, Figure 9, illustrates the extent of overall damage resulting from the ballistic penetrations. Much of the overall glass fracture in the Chemcor-plastic windshield was incurred during post-test removal from the aircraft structure and subsequent handling. More accurate display of the post-hit visibility through this article is shown in the motion picture documentation. The extent of post-hit crack propagation which would occur in flight as a result of aircraft vibration and flight loads imposed is unknown.

a. UH-1 standard acrylic windshield.

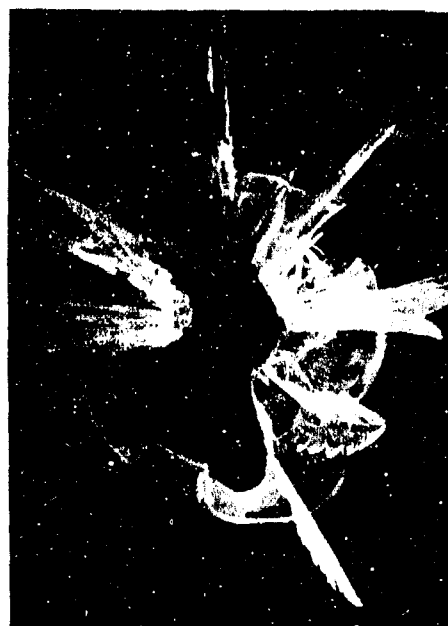
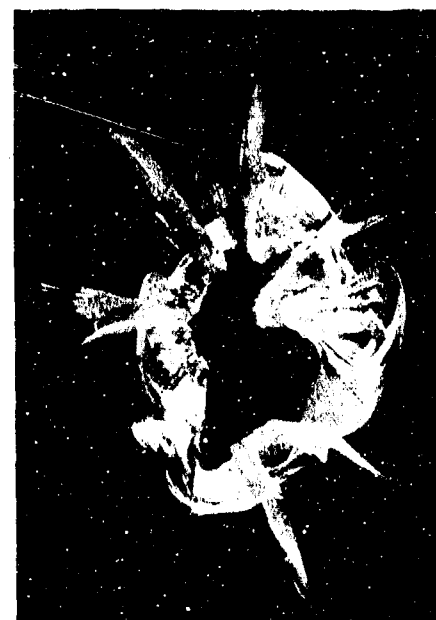
Standard
Acrylic

Additional details of the comparative material behavior are shown in the front and back-side closeup photographs, Figure 10. The witness sheets from each test are shown in Figure 11. Spall data reported for each test excluded the single perforation of the witness sheet caused by the bulk of the projectile.

Figure 10. Ballistic penetration of UH-1 windshields, front- and back-side details.

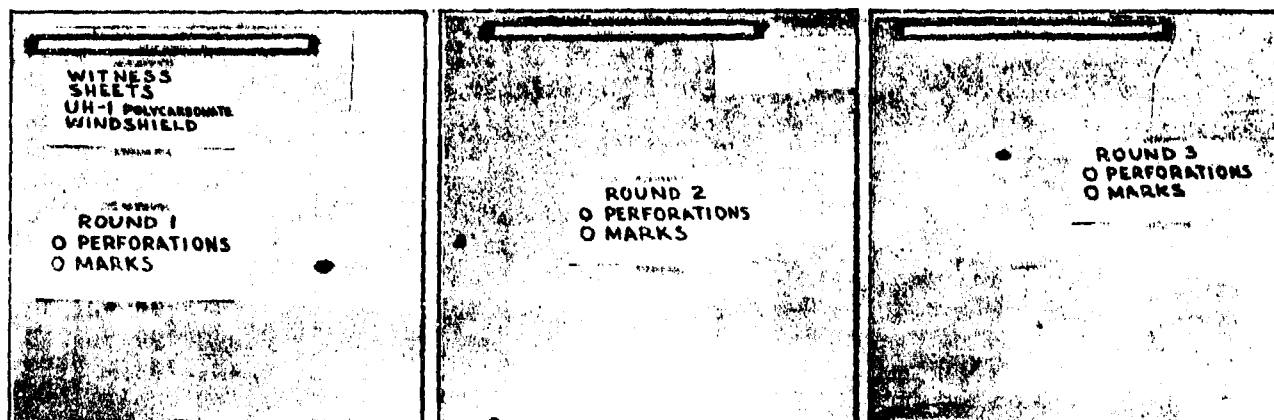
UH-1 polycarbonate windshield.

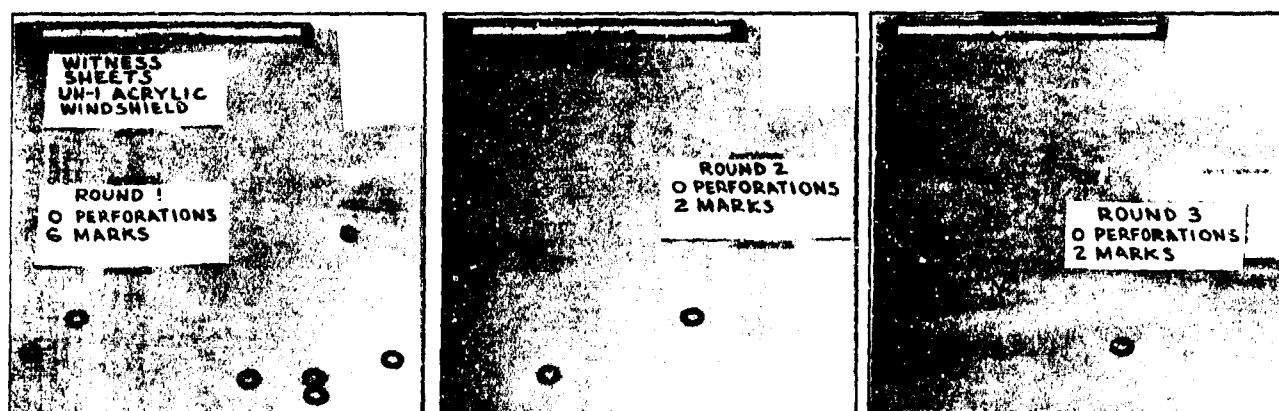
UH-1 standard acrylic windshield.

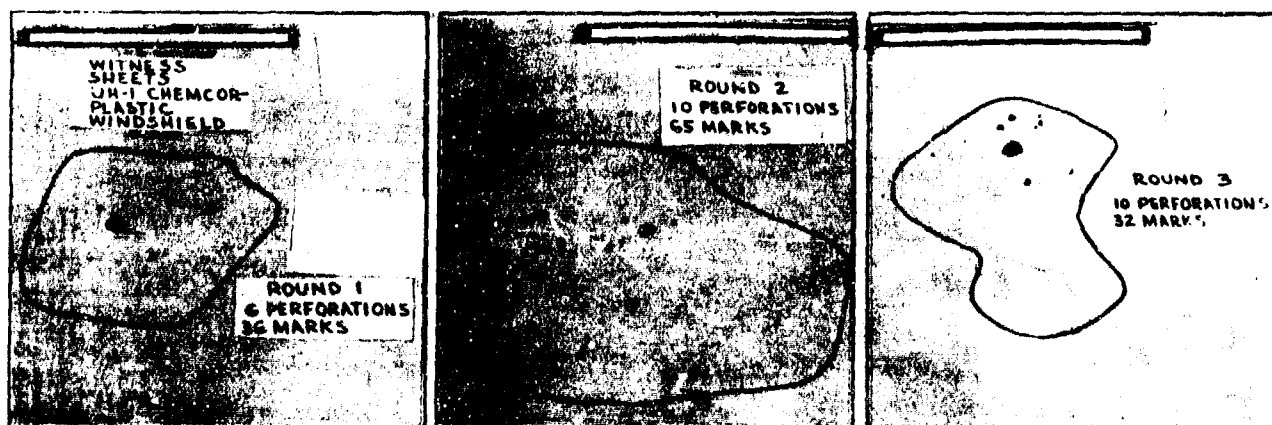
UH-1 chemcor-plastic windshield.

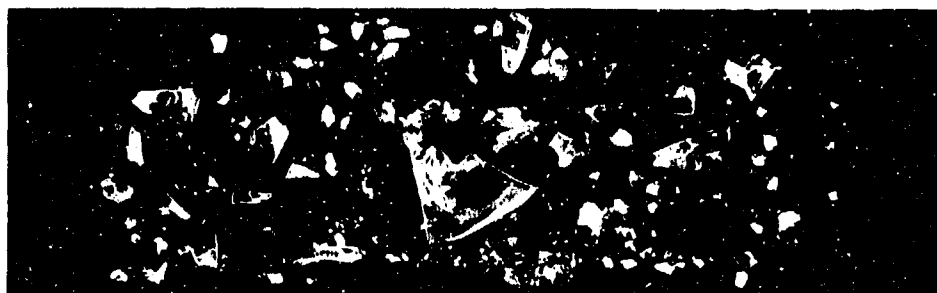
P/N 204-030-666-44 UH-1 standard windshield 0.25 as-cast plex 55 acrylic.

2. Standard acrylic windshield. The acrylic windshield fractures locally at the impact site. A wide variety of particle sizes is removed and widely dispersed. The acrylic particles are sharp edged and potentially dangerous. The extreme dispersion of the particles caused some of them to miss the witness sheet. None of the particles which struck the witness sheet resulted in a potentially lethal perforation.

The combined factors of quantity, dispersion, and cutting nature of the spall from the acrylic windshield are very unfavorable. The use of helmet visors by the aircrew would add significant eye protection against this type of spall. The

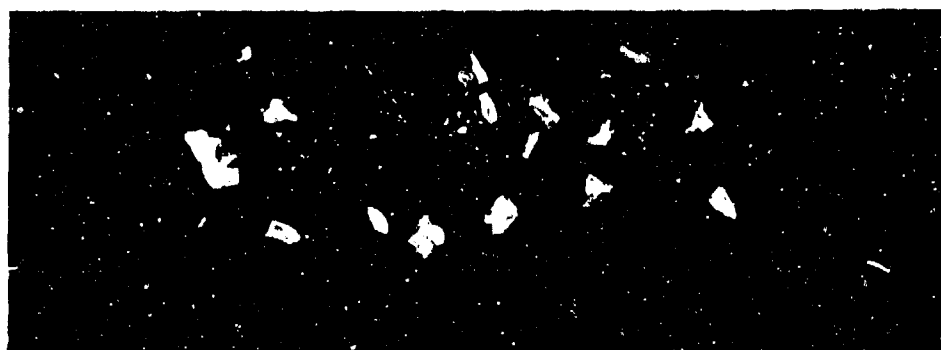
1. Chemcor-plastic composite windshield. The ballistic penetration of this windshield generated many spall particles, a number of which had potentially lethal penetrating characteristics. These penetrating particles are probably both glass and bullet fragments.

The glass outer layer acts to partially break up the projectile. The glass particles and bullet fragments, both having relatively high density, comprise the most hazardous spall. The ductility of the plastic backing ply restricts the dispersion of the spall. The higher-density glass and bullet spall strike the witness sheet at nearly the same instant as the bullet.

UH-1 prototype windshield Chemcor-plastic composite.

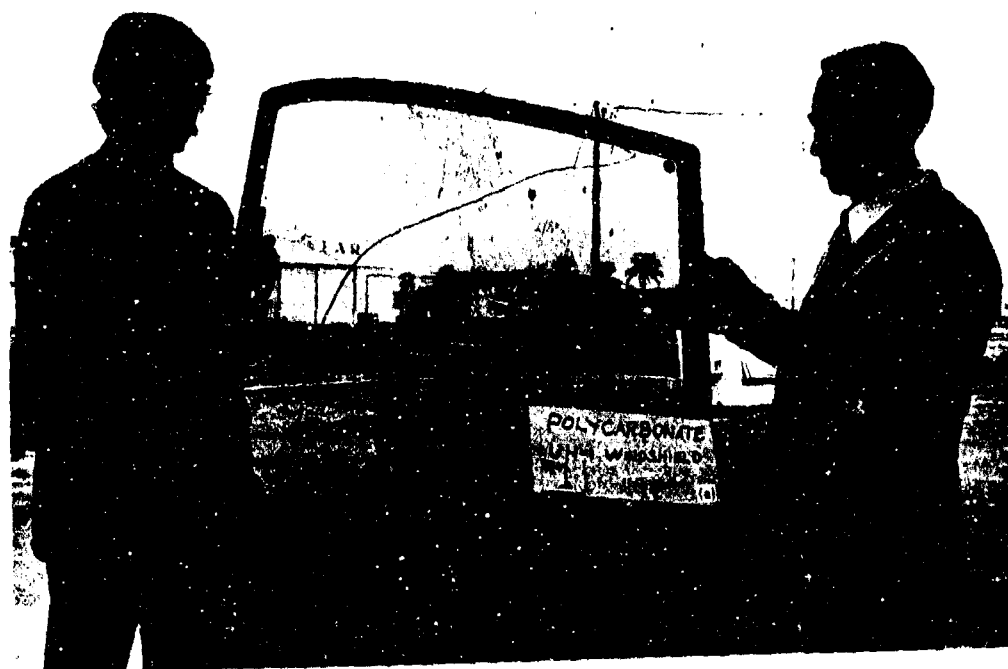
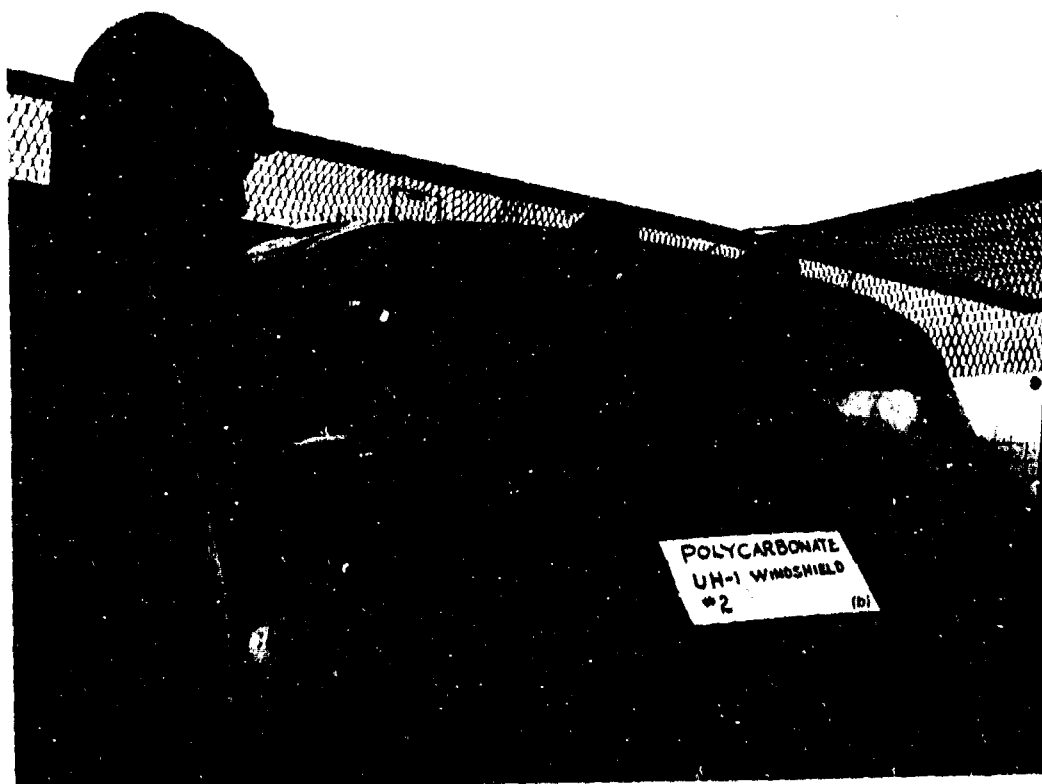
Windshield No. 1 was impacted at 114.5 knots with a four-pound bird. This impact resulted in a diagonal crack running from the upper right-hand corner to the lower left-hand edge of the windshield when viewed from the front (see Figure 15a). The bird bounced into the air, and there was no debris in back of the windshield.

Upon close examination of the part, it was noticed that the aircraft structure had bent directly above the spot where the crack terminated. The movies taken confirm the crack initiated in the center of the windshield. The fuselage was bent out into the proper position and readied for the next test.

Monolithic polycarbonate windshield No. 2 was then installed and impacted in the same manner. The impact velocity was 120.8 knots. This impact resulted in several cracks forming and the loss of two pieces of polycarbonate, one in

Figure 15. Bird-impacted UH-1 polycarbonate windshields.

each upper corner of the windshield. The two pieces fell outboard away from the fuselage. A break in the polycarbonate occurred along the upper edge attachment. This edge break permitted the remaining polycarbonate to flex inboard and allowed the bird to deflect upward into the pilot's compartment. The bird hit the top of the pressure box before falling to the floor. The center polycarbonate flexed back into position and was firmly held in place by the lower edge attachment (see Figure 15b). The fuselage again bent inward in the same upper inboard area, and the windshield cracks seemed to initiate from this area.

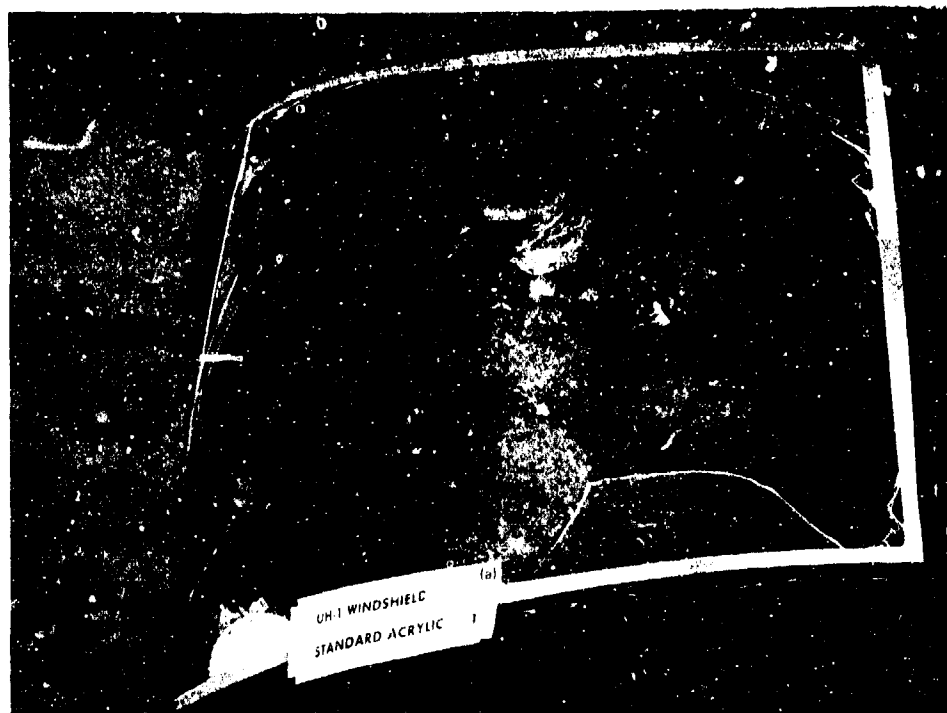
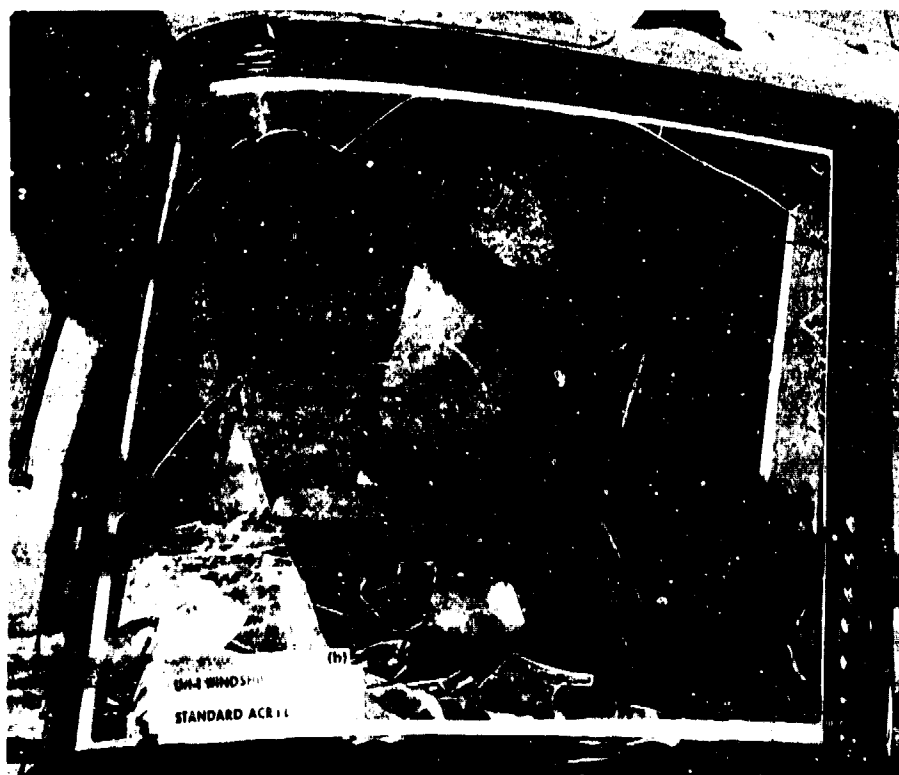
Standard acrylic windshield No. 1 was then mounted in the fuselage and was impacted with the four-pound bird traveling at 121.9 knots. The bird penetrated the windshield and hit the back of the vacuum chamber. The Plexiglas broke out of the frame with only a few jagged fragments remaining along the edge (see Figure 16a). The fuselage was not damaged by the impact.

Because of the catastrophic failure mode of the first standard acrylic windshield, the second standard windshield was fired at 85.6 knots, which is nearer the cruising speed of the UH-1 aircraft. The bird also penetrated this windshield, breaking out nearly 80 percent of the acrylic (see Figure 16b).

Figure 16. Bird-impacted UH-1 standard acrylic windshields.

b. The standard acrylic windshield at both the cruising speed (90 knots) and the maximum speed of the UH-1 is incapable of defeating a bird strike. The as-cast Plexiglas breaks into large, sharp-edged fragments which could cause serious injury to the aircrew.
